WISCONSIN HIGHWAY RESEARCH PROGRAM

PROJECT NO. 0092-01-06

**REHABILITATION TECHNIQUES FOR
CONCRETE BRIDGES**

DRAFT FINAL REPORT

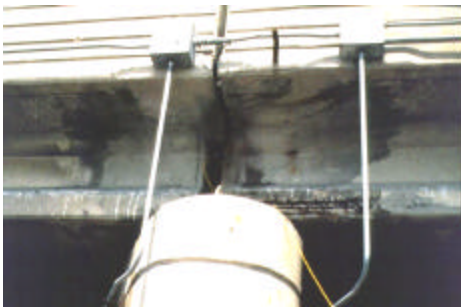
The most prevalent cause of deterioration in concrete bridges is corrosion. Diffusion of chloride ions through concrete can destroy the passivity of steel and initiate the corrosion process. In northern climates, such as Wisconsin, the primary source of chlorides is found in deicing salts used to melt snow in the winter. Bridges in northern climates are susceptible to corrosion in a manner different from bridges located in warm coastal climates. In such climates, girders are prone to corrosion mainly at the end regions (Figures 1 and 2). This is the

result of water leaking through faulty expansion joints and then reaching the girder ends. Improper drainage can also allow salt water to penetrate into other parts of the superstructure, including fascia girders. The resulting steel corrosion and the spalling of concrete, can cause irreversible damage to beam-ends. Rehabilitation of damaged beam-ends generally requires the complete removal of the damaged region, followed by reconstruction. Issues with this repair procedure include reoccurring spalls due to inadequate bond between the new and existing concrete. In addition, these types of repairs may not be very effective in the long term as contaminants in areas adjacent to the repair can, overtime, migrate to the repair region. This effect is more pronounced if drainage issues are not corrected. Since this type of damage is frequently encountered in northern states such as Wisconsin, the effectiveness of various traditional and state-of-the-art repair techniques are investigated.

Figure 1. Damaged Beam-Ends

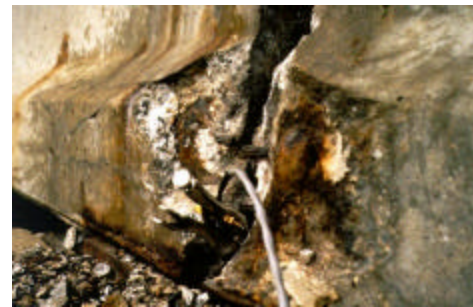
Figure 2. Close-up of Beam End

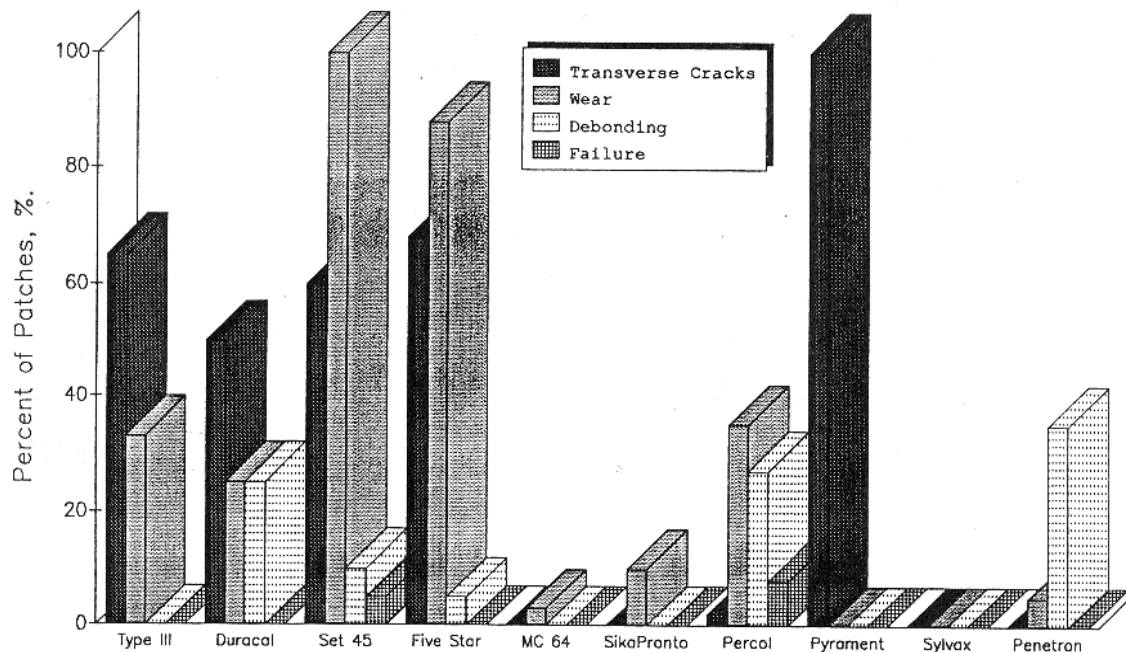
The patch materials were installed in 1991 from April to July at four test sites in four climatic regions in the United States. In addition, laboratory tests were conducted to identify correlations with field performance. The materials were evaluated on a periodic basis. The study reports findings 1 to 3 days after installation as well as one and three month's results. Figure 4 illustrates the repair performance after three months of evaluation. The percent of patches indicate the fraction of patches experiencing transverse cracking, wear, debonding, or failure. The author considered a patch repair failed when it could no longer carry traffic safely.

Figure 4. Distress Summary [1]

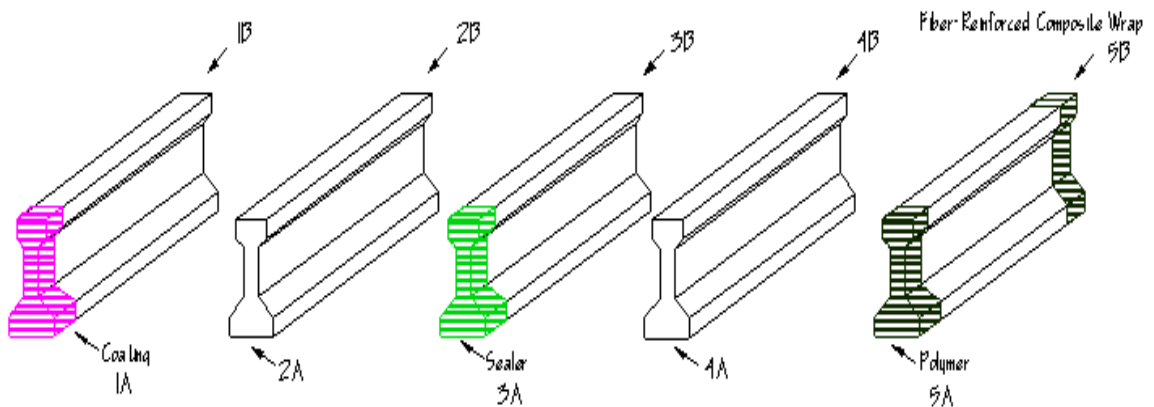
Figure 23. Laboratory Set-up Prior to Accelerated Corrosion

The test plan, detailed in Table 14 and illustrated in Figure 23 and 24, was employed to determine the effectiveness of various treatments to prevent prestressing steel corrosion. Two repair schemes were evaluated in this study. The first involved repairs where no concrete was removed and only a surface treatment was applied. Some specimens were treated with an epoxy coating, sealer, polymer coating, or CFRP composite wrap. The second repair scheme involved repairs where portions of concrete were removed and replaced with a patch material. Figure 25 illustrates the time period and repair method for each beam. End “A” indicates the west end of the beams and end “B” indicates the east end of the beams as they sat in the UWM Structural Laboratory.

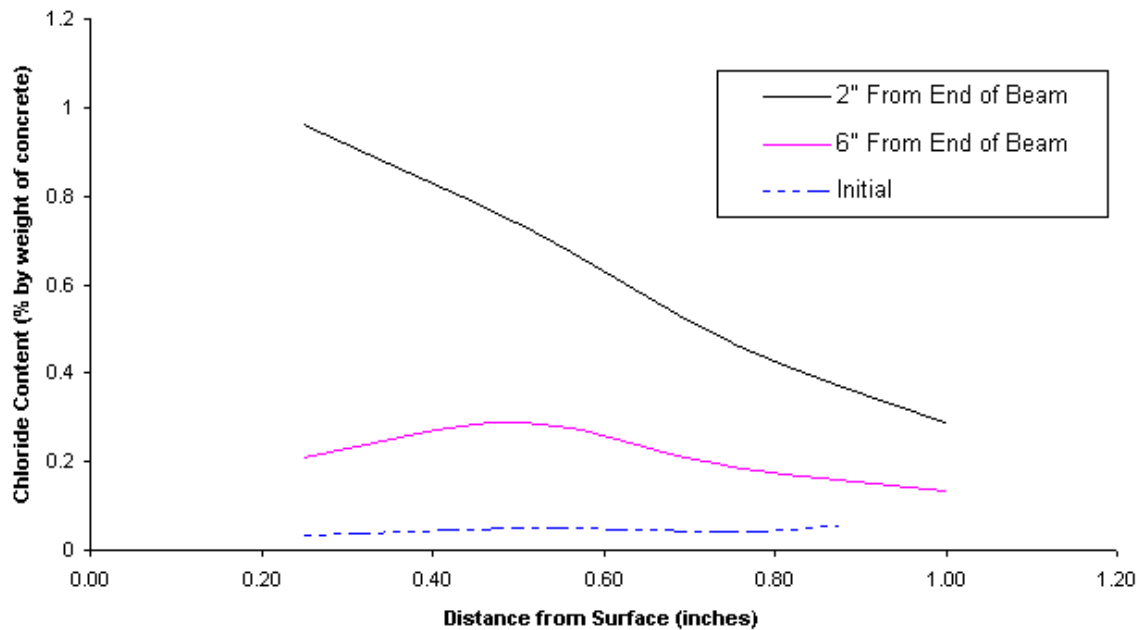
Figure 27. Comparison of Chloride Contents – Phase I

The measurements indicate high chloride concentrations near the surface, with the values decreasing with increasing distance from the surface. This is consistent with the behavior of chloride ions migrating into the concrete. Figure 27 illustrates the comparison of the collected chloride content data.

Research conducted by Lewis [26] suggests that the corrosion threshold value is 0.15% of acid soluble chloride by weight of cement. ACI Committee 222 [52] recommends the corrosion threshold value of 0.2% acid soluble chloride by mass of cement. Recently, other researchers have suggested a large variation in the corrosion threshold. In either case, the currently utilized corrosion threshold is exceeded at all depths measured at a distance of 2 inches from the end of the beam. At the location of 6 inches from the face of the beam, the corrosion threshold level is exceeded up to a depth of $\frac{1}{2}$ inch.

The highest chloride levels are observed in the beam-end with patch repairs. Acid-soluble chloride levels are on the order of 1.0% by weight of concrete is measured at depth of up to 1.0 inch. It appears that the interface between the old and new concretes may have allowed accelerated intrusion of chlorides deep into the patch and old concrete.

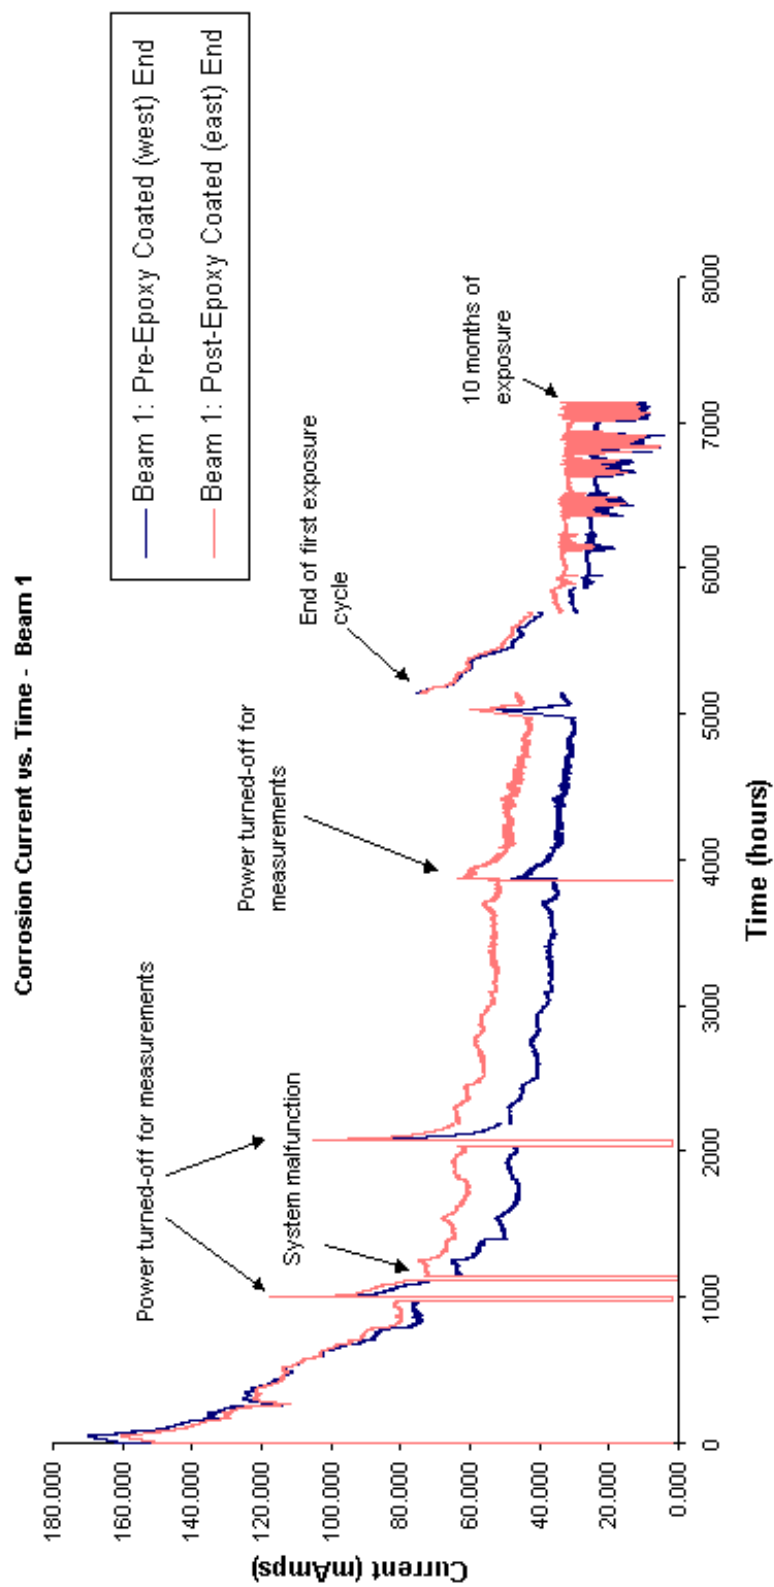
Figure 28. Corrosion Current vs. Time – Beam-Ends 1A (West) and 1B (East)

All curves exhibit a decrease in current over the 10 months of the experiment reported here. This reduction is commonly observed in such experiments, and is due in part to the fact that corrosion products increase the resistance at the surface of strands. Because of the exponential nature of the curve, the results obtained subsequent to the first 10 months of exposure are not plotted. The curves for the two ends of beam 1 are approximately similar until about the 800-hour mark, after which the curves begin to diverge. The pre-coated beam end (epoxy coated from Day 1) demonstrates a larger decrease in current at approximately 1500 hours in comparison to the untreated end. The cumulative area under the corrosion current versus time graph is indicative of the amount of steel loss due to corrosion. Since the pre-coated end has a smaller cumulative area under its curve, it can be deduced that this end is experiencing less steel loss over time. Therefore, the beam end treated with epoxy coating since Day 1 is experiencing less steel corrosion in comparison to the untreated (later coated) end.

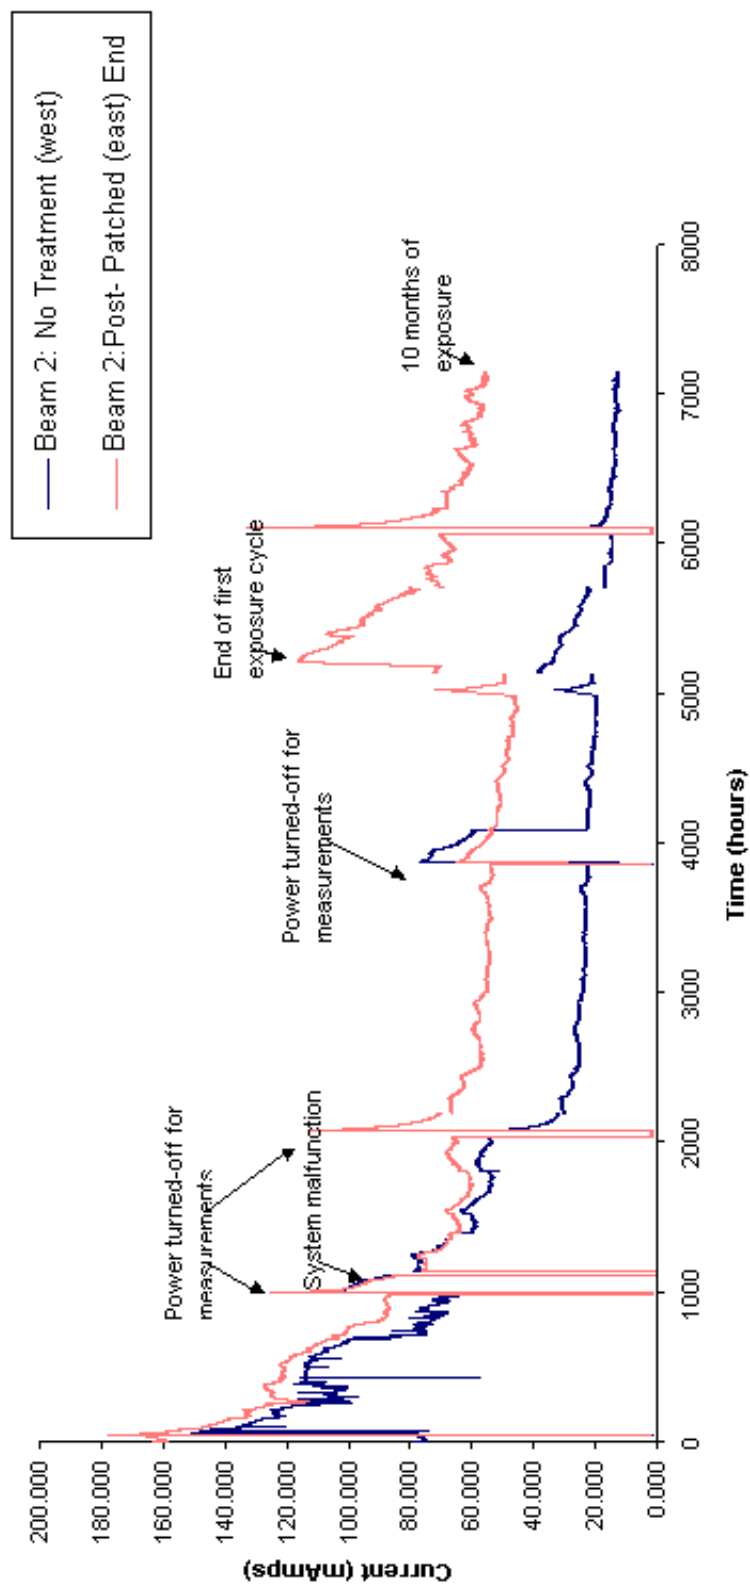
Figure 29. Corrosion Current vs. Time – Beam-Ends 2A (West) and 2B (East)

The corrosion vs. time curves for the two ends of beam 2 are relatively similar until about 2000 hours into the experiment. After which, the “no-treatment” or west end experiences a significant decrease in current. Since these ends were exposed to the same exposure condition and both were initially untreated, their curves should be approximately equal for the first 6 months of the study. Given that the untreated end diverges so significantly, it can be deduced that there may have been electrical connection problems occurring with this end. It was observed that at the end of the first phase of exposure, there was only one undamaged connection between the beam end and the applied voltage. Therefore, the difference observed between the curves for the ends of beam 2 is more than likely due to electrical connection

problems, and does not reflect that less corrosion is occurring in the untreated, west end compared to the untreated, east end.

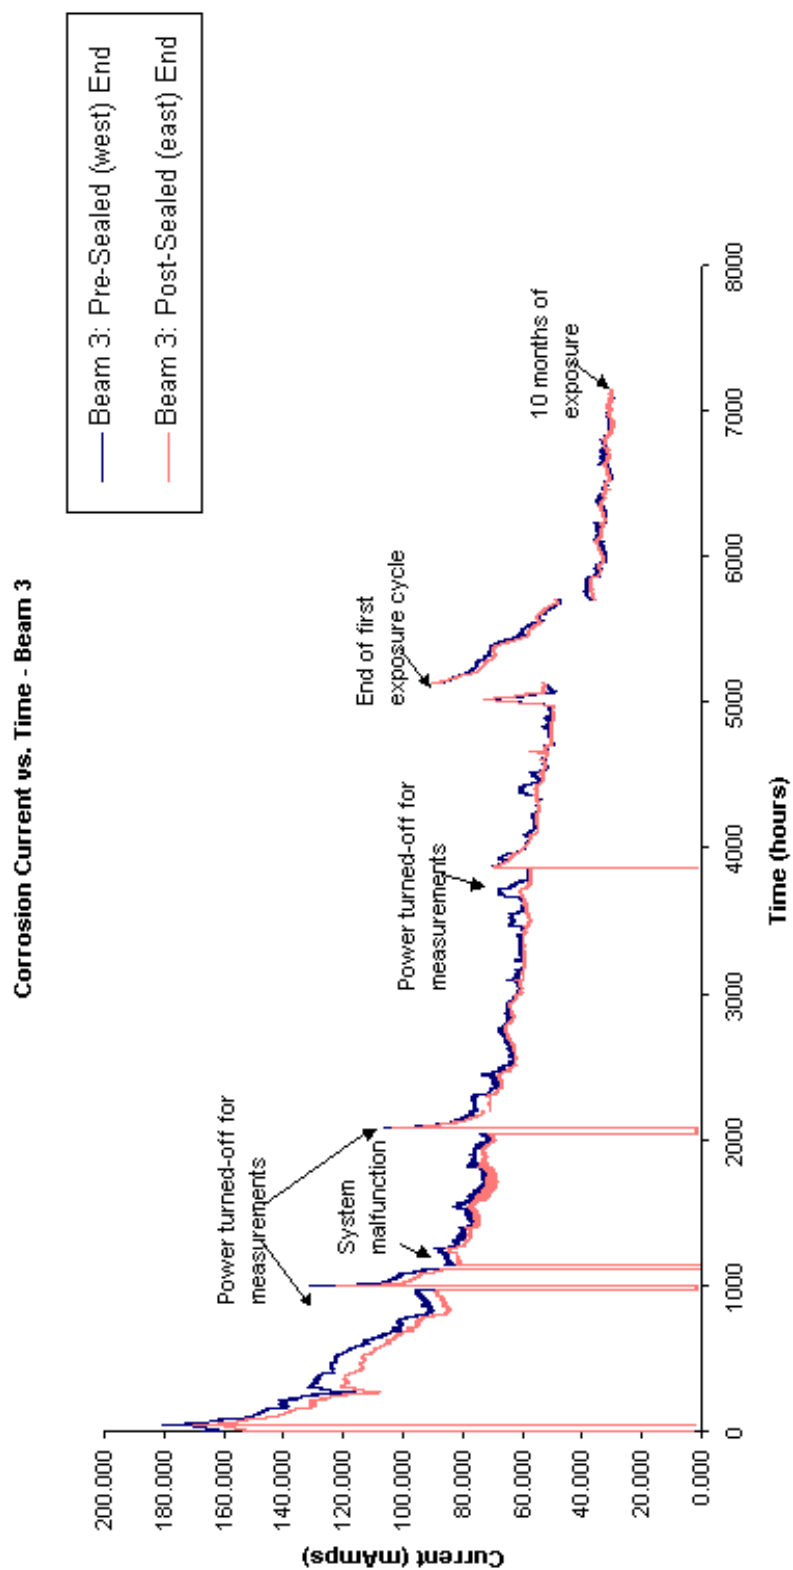
Figure 30. Corrosion Current vs. Time – Beam-Ends 3A (West) and 3B (East)

The corrosion current versus time curves for the two ends of beam 3 are generally similar for both the pre-sealed (west) end and the untreated, later sealed (east) end. This behavior is observed at the end of the first phase of the experiment and continues after 10 months of exposure. Since these curves are exhibiting similar behavior, it can be concluded that the pre-sealed end behaved the same as the initially untreated end. Therefore, this data seems to indicate that the penetrating sealer did not have a noticeable effect on preventing corrosion and the subsequent steel loss in the beam.

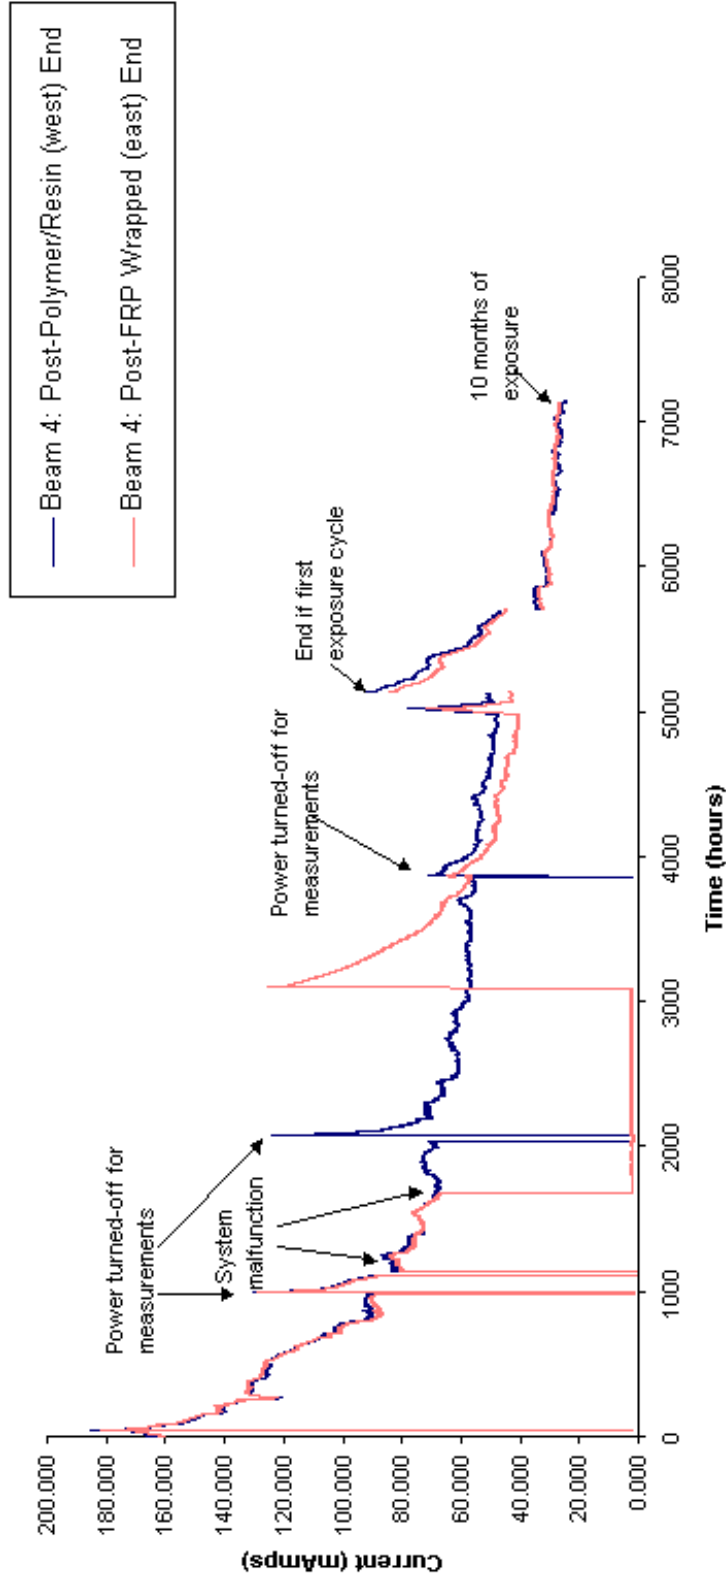
Figure 31. Corrosion Current vs. Time – Beam-Ends 4A (West) and 4B (East)

The corrosion current versus time curves for the two ends of beam 4 are nearly the same for both initially untreated ends. The exception is between approximately 1700 and 3000 hours, where the current drops to zero for the post-FRP wrapped (east) end. The drop in current was due to a loose connection between that end and the applied voltage. When the drop in current was observed, the connection was evaluated and remedied. After the readings stabilized once the connection was reestablished, the behavior of both curves returned to be nearly equal. Since both ends were initially untreated and subjected to the same exposure conditions, the graphs should display nearly the same behavior. For the 10 months of total collected data, the curves continue to be approximately equal after the polymer (resin) and FRP wrap was applied.

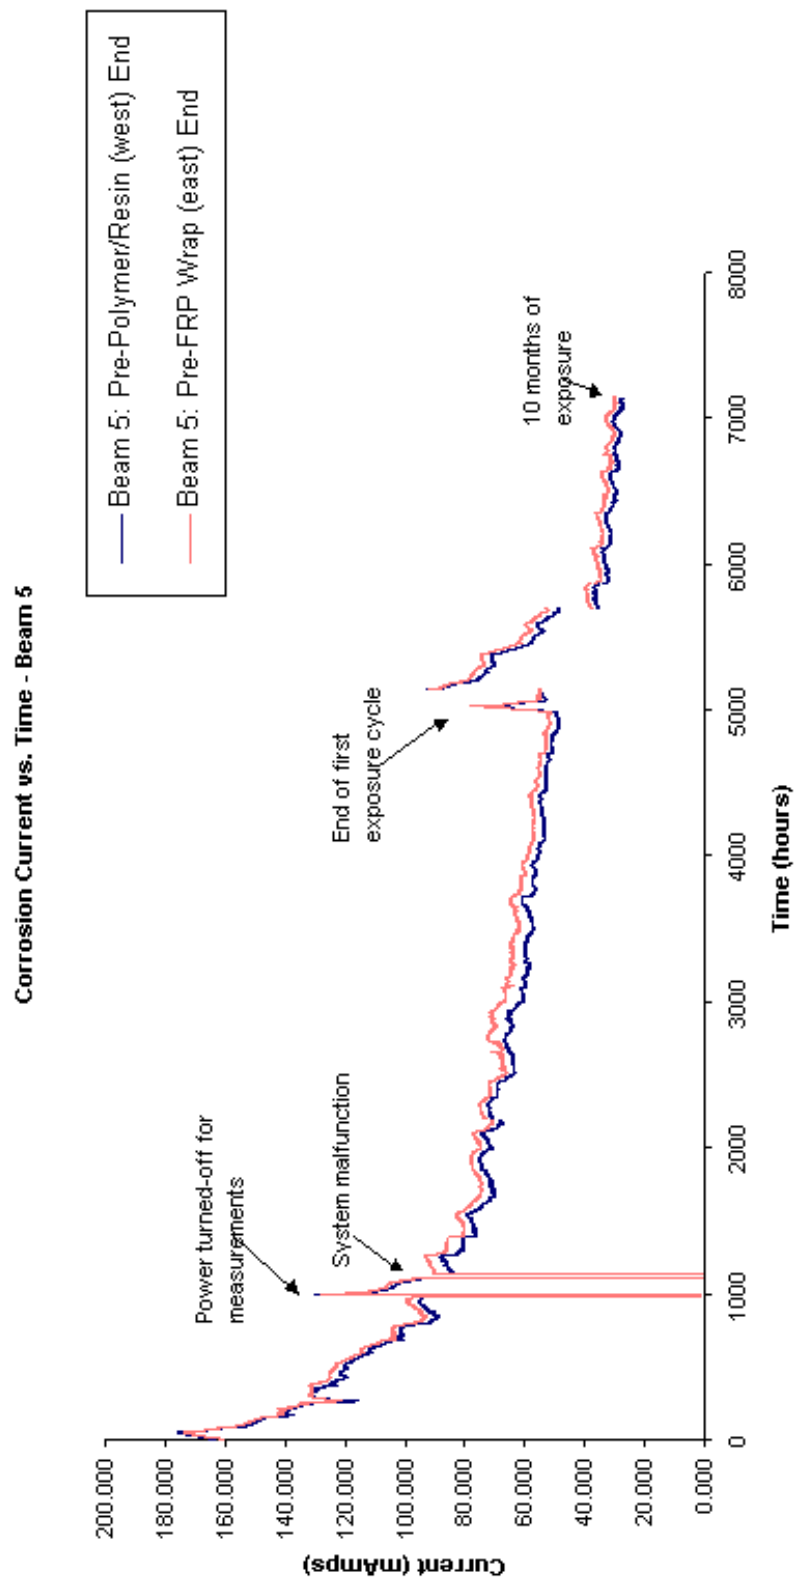
Figure 32. Corrosion Current vs. Time – Beam-Ends 5A (West) and 5B (East)

The corrosion current versus time curves for the two ends of beam 5 are nearly the same for the 10 months of collected data. The end pretreated with the polymer (resin) has a slightly less corrosion current in comparison to the end pretreated with FRP wrap (east). Form the

existing data collected, it can be concluded that both ends are experiencing similar corrosion damage, and therefore have similar effectiveness.

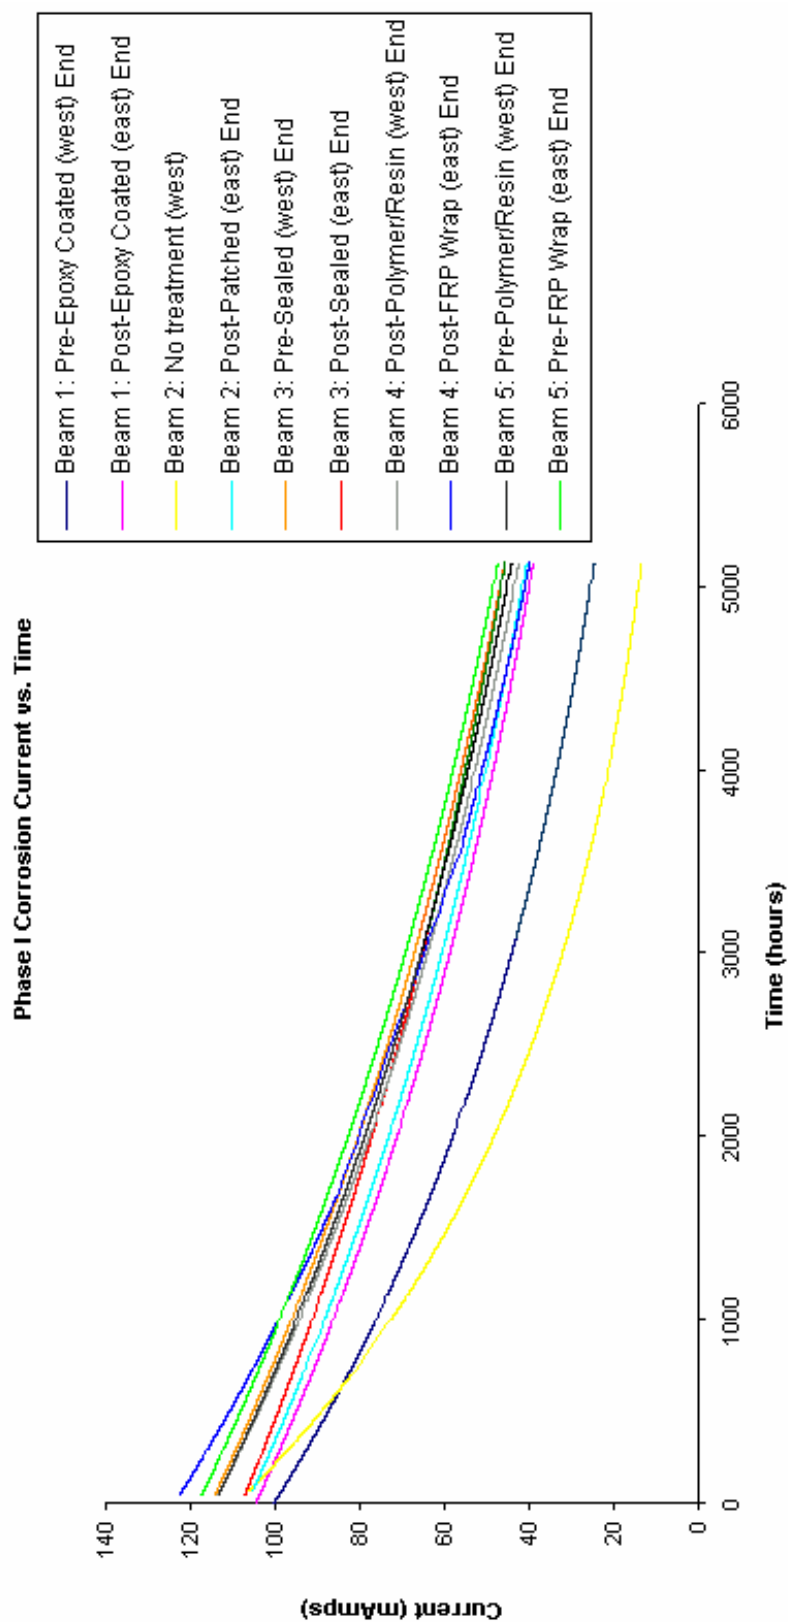
Figure 39. Best-Fit Curve: Corrosion Current vs. Time – All Beam Ends

Figure 39 illustrates the combination of corrosion current versus time for all the beam-ends. The “no treatment” end of beam 2 exhibits the lowest corrosion current over time. As explained earlier, this is likely due to electrical connection problems with this particular end, and is not representative of its true behavior in preventing corrosion. The next lowest curve is the end of beam 1 pretreated with a coating. The end that exhibits the largest corrosion current versus time is the end pretreated with the FRP wrap. However, all curves for each of the beam-ends are clustered closely together. Therefore, based on the 6-month exposure data, a conclusive assessment of the effectiveness of various treatments cannot be made.

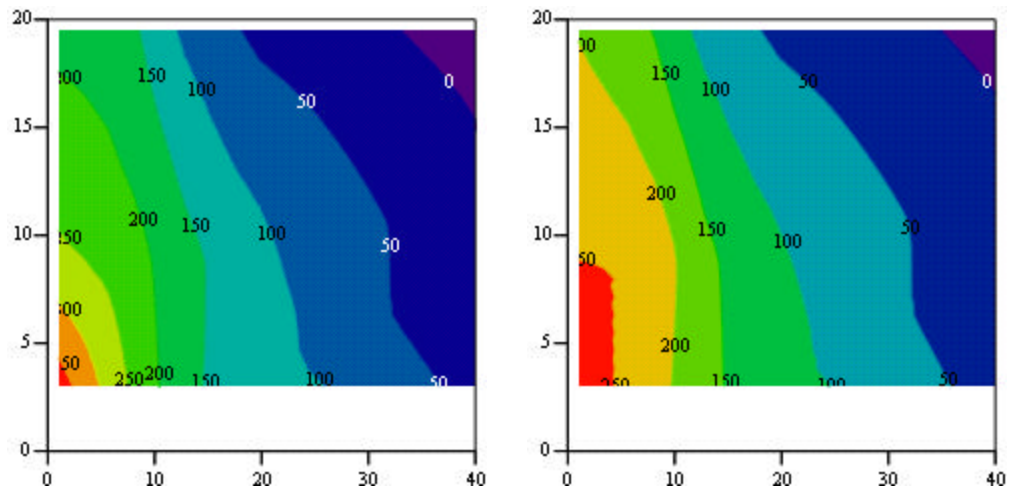
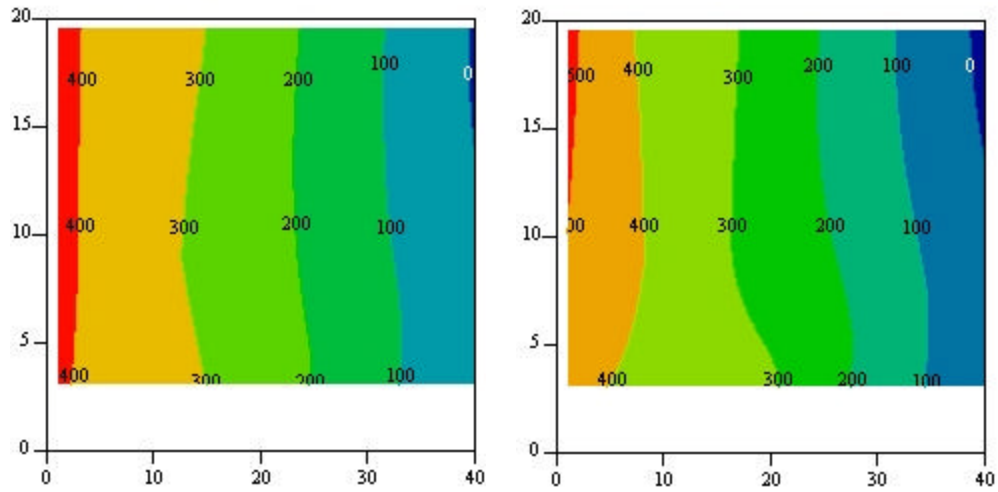
Since the polarity of the experimental setup is reversed from the standard method, the values obtained are in the positive range. According to Emmons [15] interpretation, after 6 months of exposure to a corrosive environment, the half-cell readings for the end of beam 1 indicate that corrosion is not occurring. The half-cell readings (at 6 months) for the ends of beam 2 and 4 indicate that it is inconclusive whether or not corrosion is occurring. However, the east end of Beam 3 has some half-cell readings on the bottom flange outer corner that indicate corrosion is occurring at these regions. The half-cell potential readings for beam ends 2A (no treatment) and 2B (patched) after 18 months of exposure clearly show corrosion activity in the beam-ends. Comparisons of Figure 45 with Figures 47 and 51, and Figure 46 with Figures 48 and 52 clearly show the progression of corrosion activities.

Half-cell potential readings were no longer taken on the surfaces treated after the first 6 months of exposure. The measurements were only taken on the non-treated beam-ends since surface treatments provide a non-conductive barrier that renders the half-cell measurements ineffective. The ends of beam 2 were the only remaining beam-ends that did not receive a surface treatment. After 10 months of exposure, the patched (east) end yields a higher potential in comparison to the untreated end. This trend is also observed at the end of 18 months. Figure 52 (patched end) shows a much larger area with half-cell potential readings of over 400 compared to Figure 51 (untreated end).

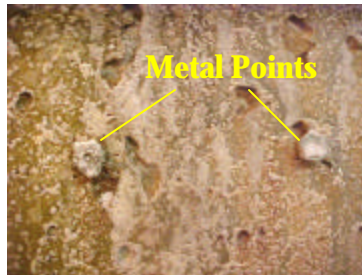
Figure 59. Measurement Points

data over the course of the experiment. There were also difficulties encountered obtaining consistent readings with the measurement device. The tip of the device was conical, and hence the measurements could vary depending on the angle the device was placed into the point. Since many of the metal points were located in the path of the salt water, overtime they softened, with many corroding (see Figure 59).

Due to the softening of the metal, some of the “dimples” or depressions in the center of the points became warped. Hence, the readings would vary depending on where in the “dimple” the tip of the measuring device was placed. It was decided to not consider the gathered strain measurements due to the inconsistencies and inaccuracies of the data.

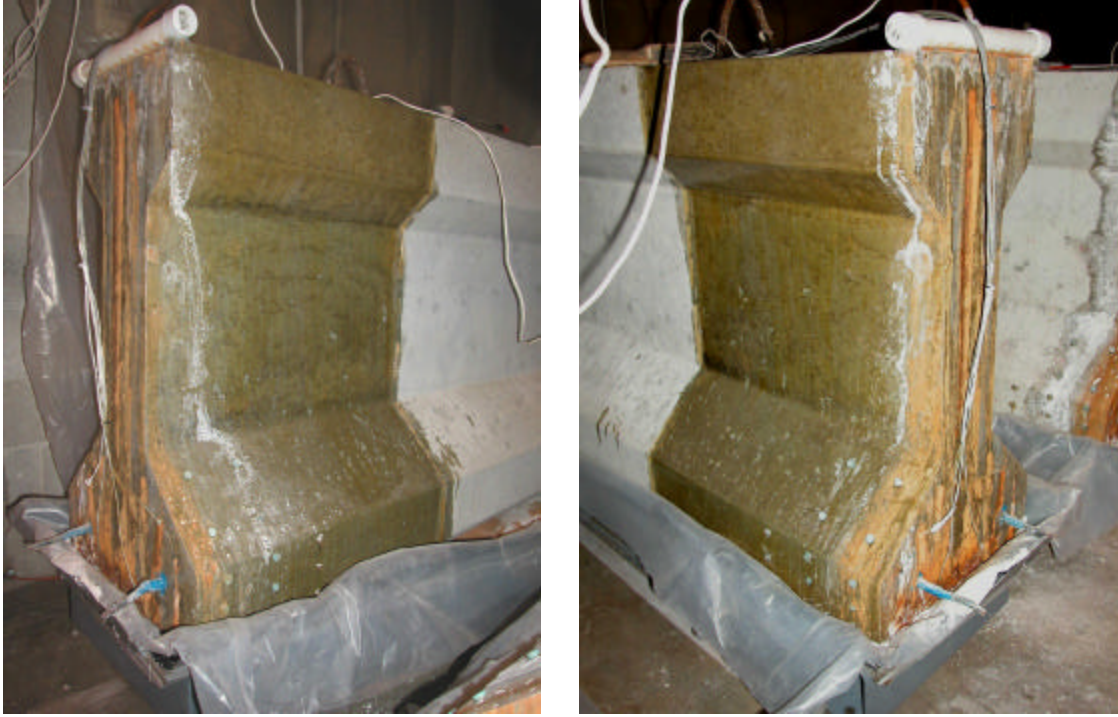
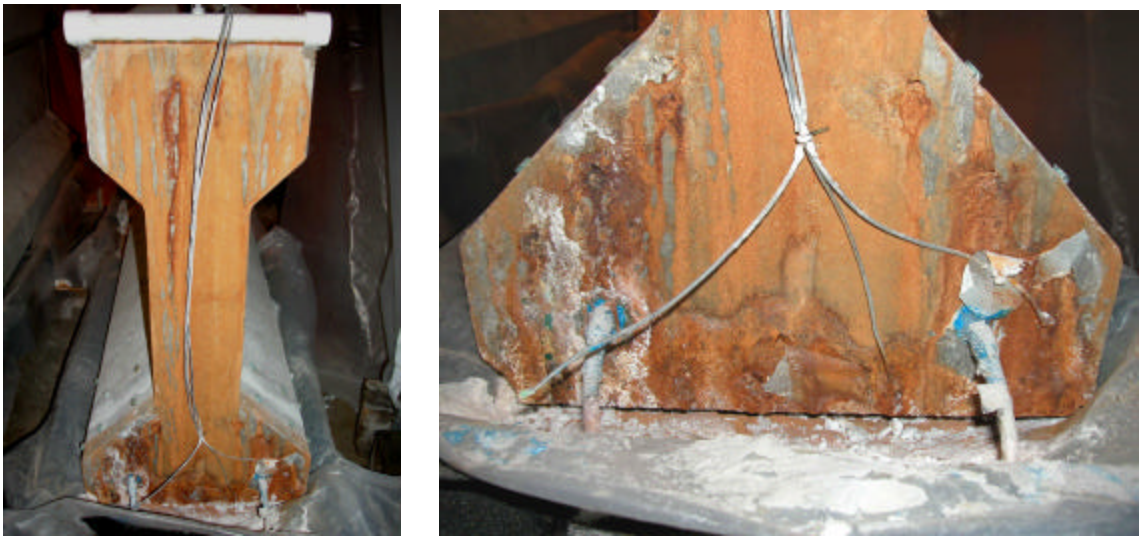
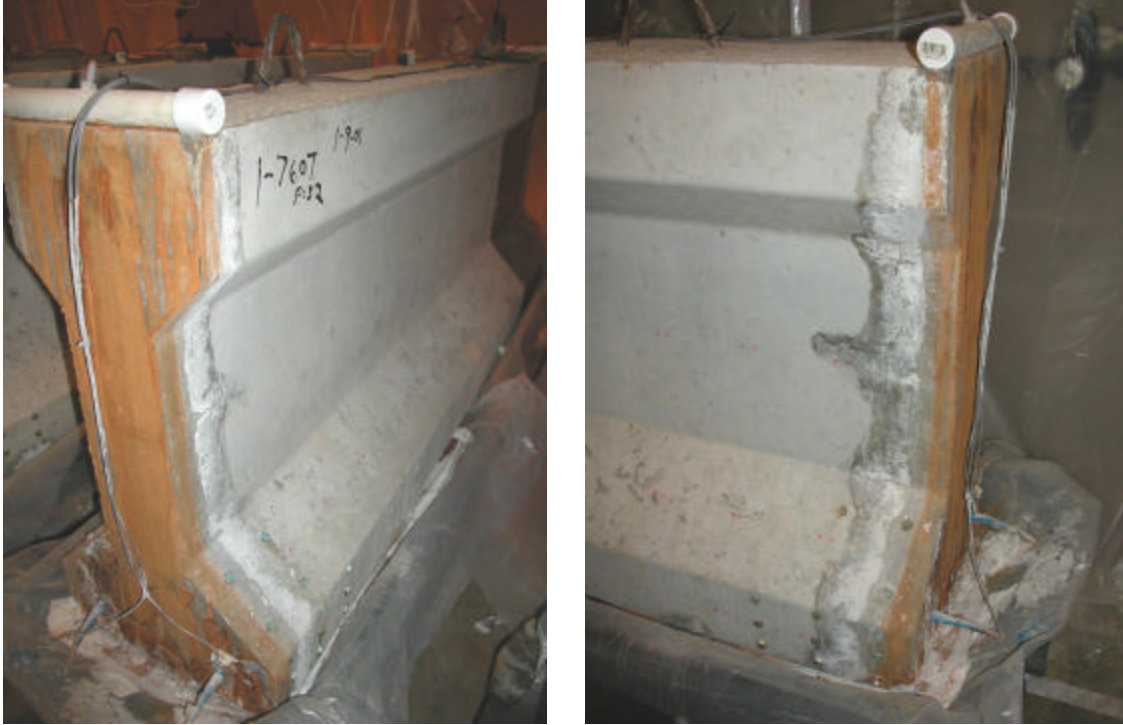
west end (1A) initially. Figure 60 illustrates the condition of 1A (pre-coated end) after 6 months of exposure. Figure 61 illustrates the condition of the southwest and northwest faces. Figure 62 illustrates the condition of the east end 1B after 6 months of exposure. Figure 63 illustrates the condition of the southeast and northeast faces.

At the completion of the first exposure cycle the beam-ends had heavy salt residue along the front faces and on some portions of the bottom flanges. Rust stains were also evident along the path of the salt water. No major spalling or cracking was observed. Some flaking of concrete was observed at the corners of the beam. In addition, corrosion products were observed on the exposed tendon ends, and were found to increase in amount over the course of the exposure.

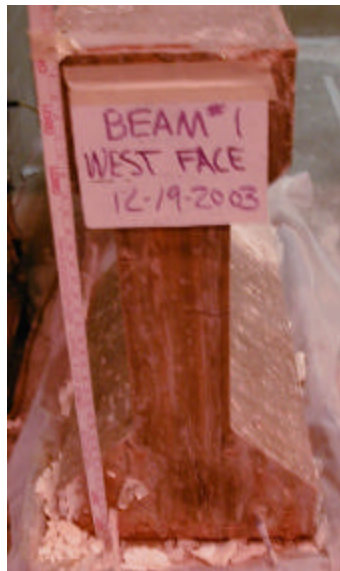
Figure 64. Beam End 1A: West End (pre-epoxy coated)(after 18 months)

ground and thoroughly washed to remove all debris. The surface preparation and surface treatment application information was detailed in section 4.8. The east end (1B) was then treated with the epoxy coating. Figure 64 illustrates the condition of the west end (1A) after 18 months of exposure. Figure 65 illustrates the condition of the southwest side at the west end 1A. Figure 66 illustrates the condition of the east end face and southeast side of 1B (post-coated) after 18 months of exposure. Since the first 6-month exposure cycle did not result in the concrete spalling or significant tendon corrosion (section 5.1.4), the configuration of the saltwater dispersion system was altered slightly to increase the likelihood of corrosion after the second 6-month cycle. Pipes (1 foot long) were added along the north and south sides of each beam end to allow salt water to flow along the side face of the beams. The altered salt-water distribution setup was able to disperse water to both the sides and face of the beams. In addition, due to the new setup all of the beams were exposed to more water at a slightly faster flow rate.

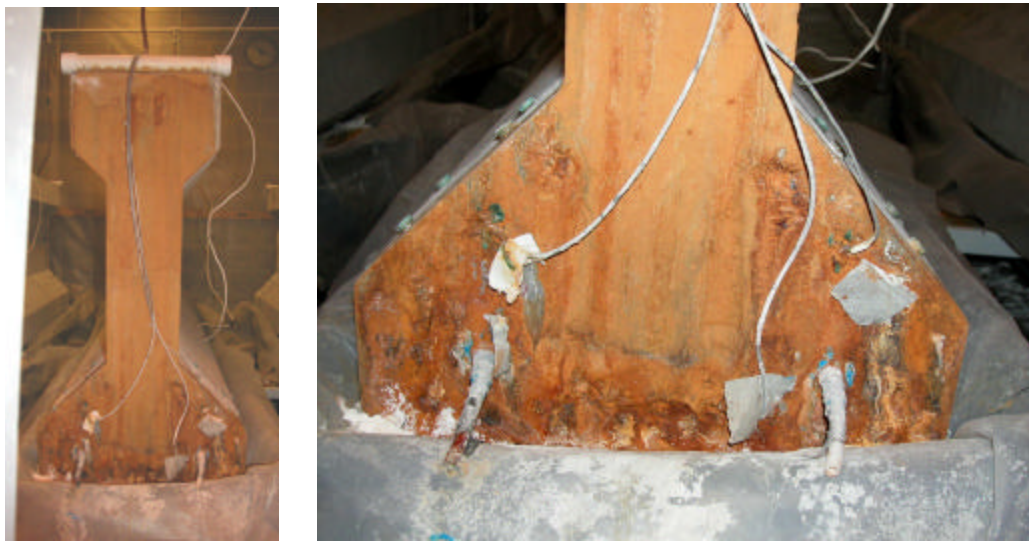
Figure 67. Beam End 2A: West End (untreated)(After 6 months)

Both the west (2A) and east (2B) ends remained untreated for the first exposure cycle. After 6 months of exposure, portions of concrete were removed from the east end to facilitate installation of a patch repair. Figure 67 illustrates the condition of the west (untreated end 2A) after 6 months of exposure. Figure 68 illustrates the condition of the southwest face. Figure 69 illustrates the condition of the east (untreated end) after 6 months of exposure. Figure 70 illustrates the condition of the southeast and northeast faces.

At completion of the first exposure cycle the beams-ends had heavy salt residue along the front faces and on some portions of the bottom flanges. Rust stains were also evident along the path of the salt water. No major spalling or cracking was observed. Some flaking of concrete was observed at the corners or edges of the beam. In addition, corrosion products were observed on the exposed tendon ends, and were found to increase in amount over the course of the exposure.

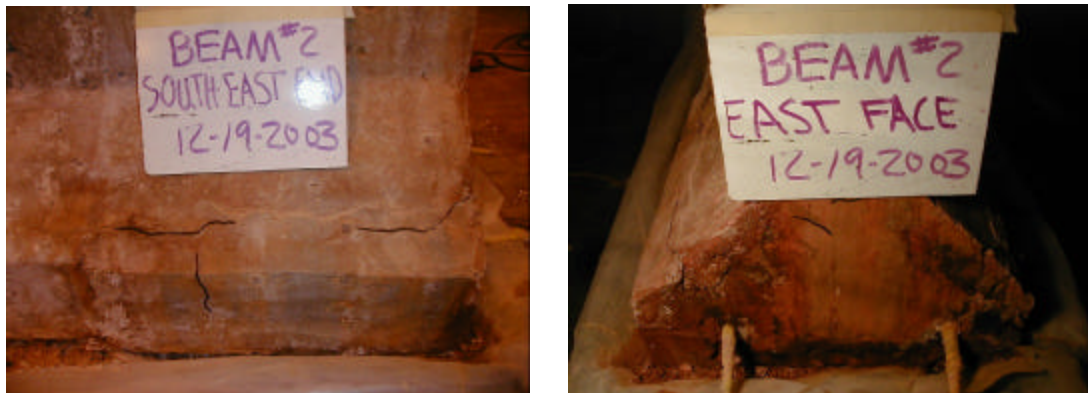
Figure 77. Beam End 2B: Closer views (After 18 months)

Figures 76 and 77 illustrate the condition of the southeast and northeast faces (patched) after 18 months of exposure.

After 10 months of corrosion exposure, the beam-ends of beam 2 were experiencing significant rust staining and salt residue. No spalling or major cracking was observed on the untreated (west) end. However, since the end was covered heavily in salt deposits, it was difficult to observe whether or not small hairline cracks were occurring. The patched (east) end experienced no major spalling, but cracks were observed in the patched region of the beam. Also, a vertical crack running the full height of the center section of the southeast end

approximately 3 inches from the edge was observed. Increased corrosion products were observed at all exposed steel tendon ends.

At the conclusion of testing (after 18 months of exposure), both ends of beam 2 had developed extensive cracking and corrosion stains were evident. All crack maps are shown in section 5.3 of this report.

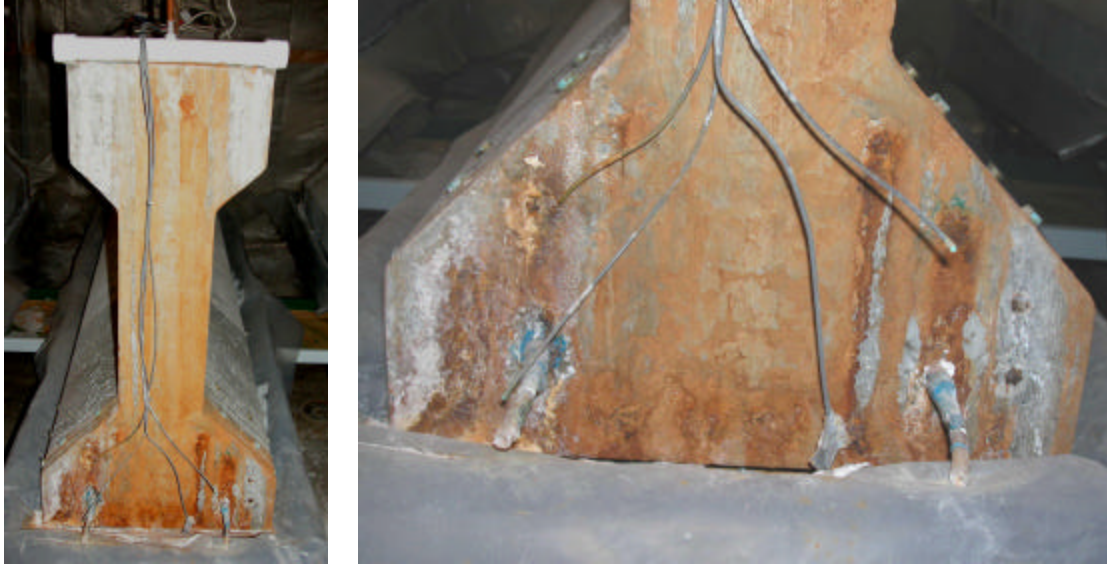
Figure 78. Beam End 3A: West End (pre-sealed)(After 6 months)

At the completion of the first exposure cycle the beam-ends had heavy salt residue along the front faces and on some portions of the bottom flanges. Rust stains were also evident along

the path of the salt water. No major spalling or cracking was observed during the first six months of exposure. Some flaking of concrete was observed at the corners of the beam. In addition, corrosion products were observed on the exposed tendon ends, and were found to increase in amount over the course of the exposure.

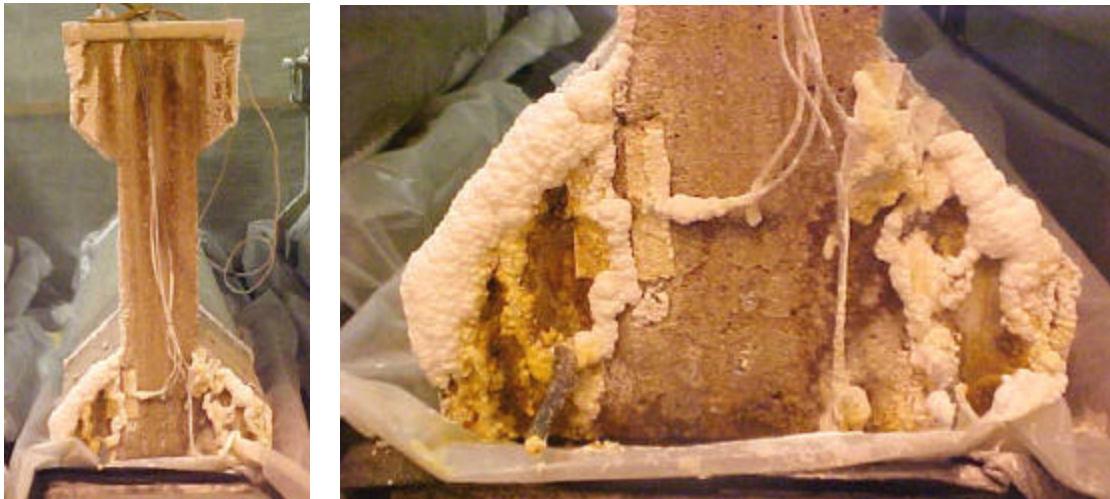
Figure 82. Beam End 3A: West End (pre-sealed) (After 10 months)

After approximately 10 months of exposure, the ends of beam 3 were experiencing significant rust staining and salt residue deposits. No spalling was observed on either of the beam-ends at that time. However, since the ends were covered heavily in salt deposits, it was difficult to observe whether or not small hairline cracks were occurring. Several cracks were observed on

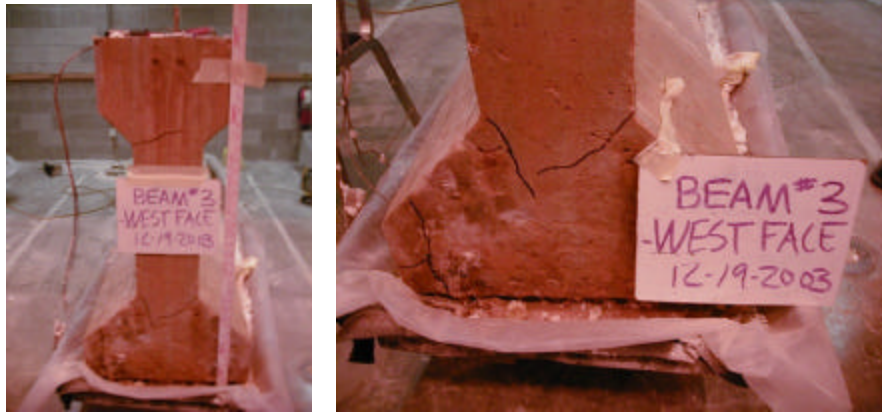
Figure 83. Beam End 3A: West End (pre-sealed)(After 18 months)

At the conclusion of testing (after 18 months of exposure), both ends of beam 3 had developed extensive cracking and corrosion stains were evident. All crack maps are shown in section 5.3 of this report.

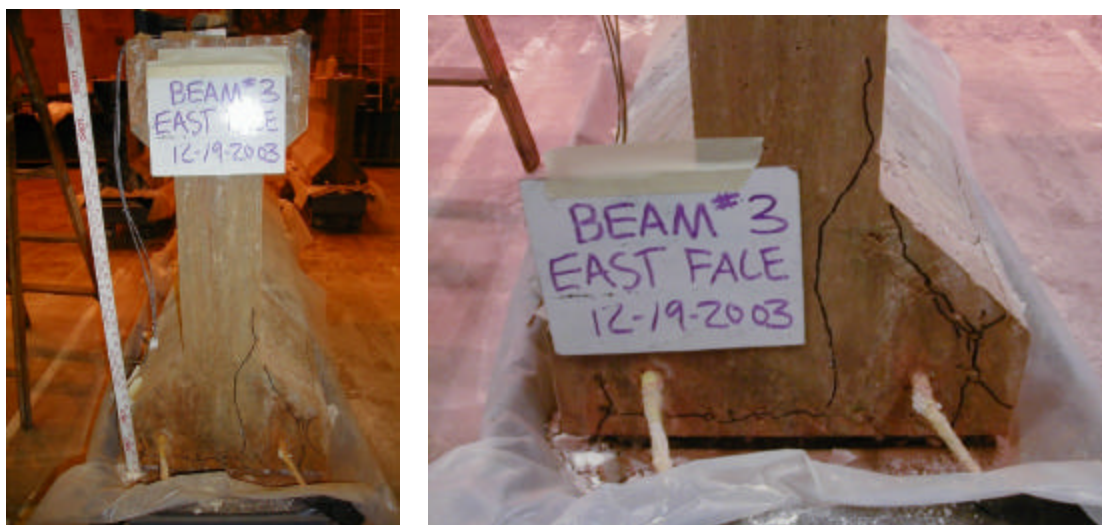
Figure 85. Beam End 3B: East End (After 18 months)

the post-sealed (east) end of the beam. A large horizontal crack on the northeast bottom flange, about 10 inches in length, was observed. Also, a vertical crack on the bottom flange of the east face was observed.

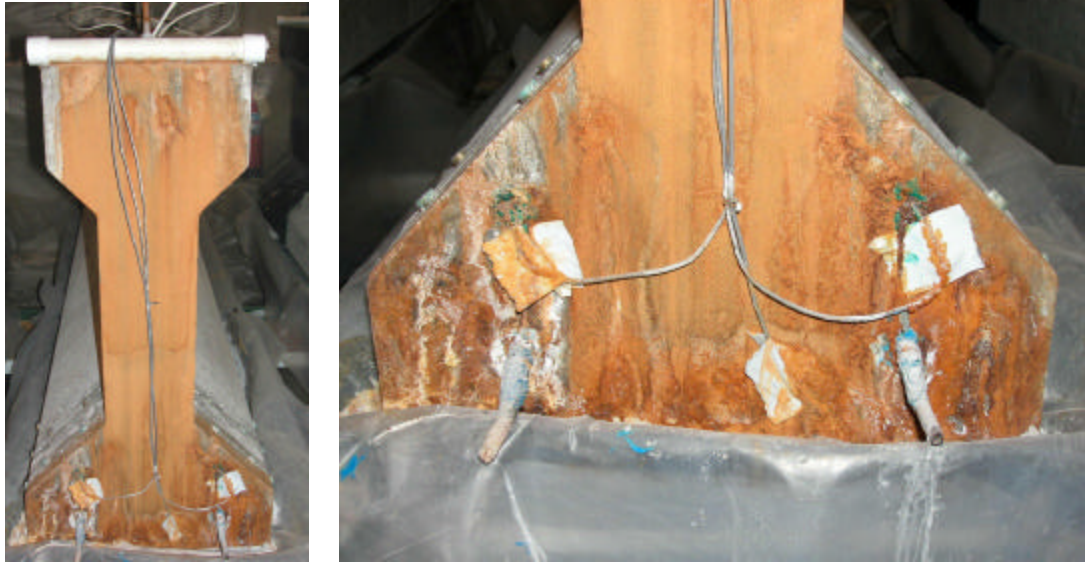
Figure 87. Beam End 4A: West End (untreated, post-polymer)(After 6 months)

At completion of the first exposure cycle the beams-ends had heavy salt residue along the front faces and on some portions of the bottom flanges. Rust stains were also evident along

the path of the salt water. No major spalling or cracking was observed. Some flaking of concrete was observed at the corners or edges of the beam. In addition, corrosion products were observed on the exposed tendon ends, and were found to increase in amount over the course of the exposure.

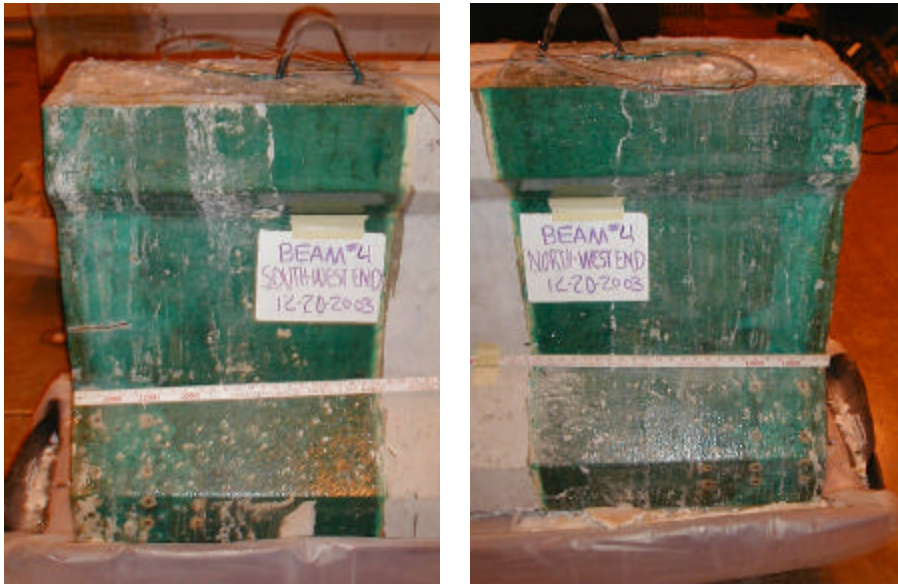
Figure 92. Beam End 4A: Southwest Face (left), Northwest Face (right) (After 18 months)

No spalling or major cracking was observed on either of the beam-ends at the end of 18 months of exposure.
